Forgotten Wrecks  
of the  
First World War

# SS *Westville*

## Site Report

***SS WESTVILLE*  
SITE REPORT**

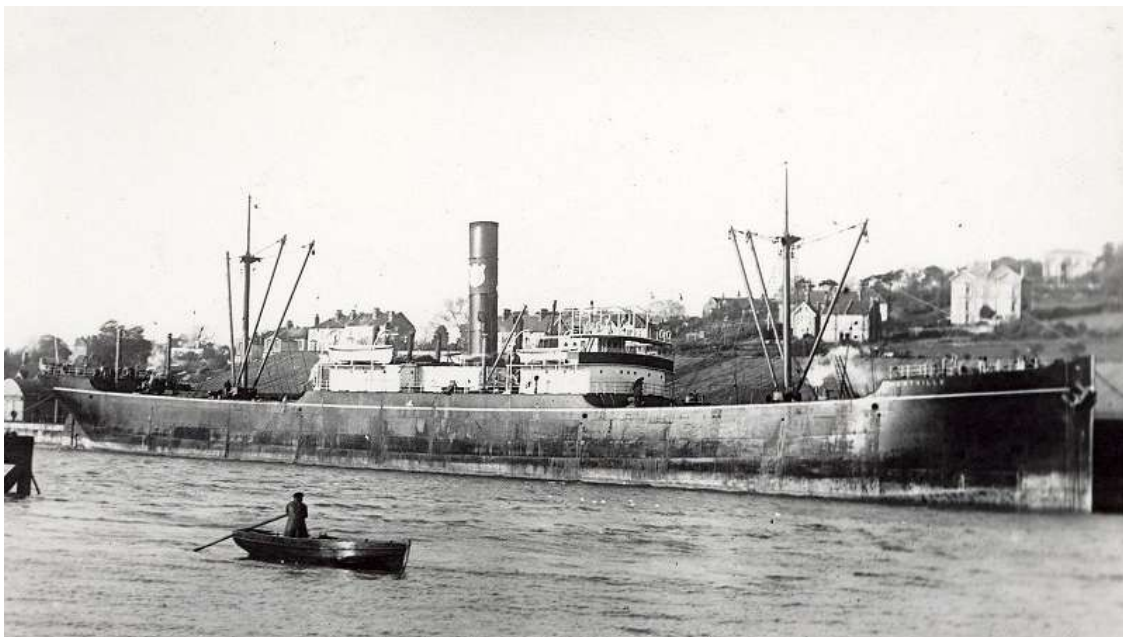
Figure 1: *SS Westville* (ENTaylor collection (courtesy of D Wendes))

*SS Westville* was built by John Readhead in South Shields and completed in August 1913. The ship was a steel screw steamer with one deck having a gross tonnage of 3207. The 335ft 3ins (c.102m) long ship had a beam of 47ft 6ins (c.14.5m) and was powered by a three cylinder triple expansion engine with two single ended boilers. It had 310 nominal horse power.

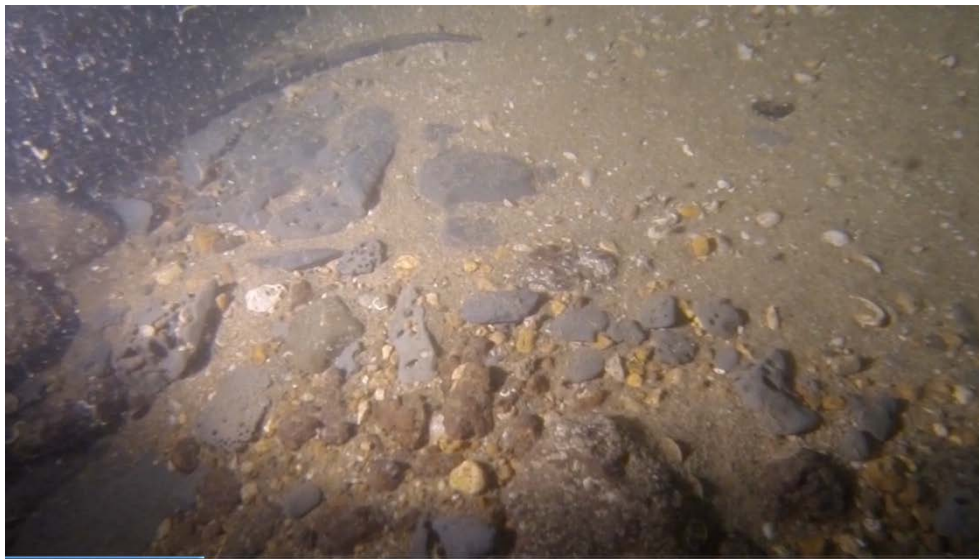
The remains of SS *Westville* lie in around 40m depth of water on a sand and shingle seabed (Figure 3) and are moderately intact. The wreck is leaning half over onto its port side with the bow, which is quite broken up, towards the south east.

Figure 3: The seabed around the *Westville* is a mixture of sand and shingle

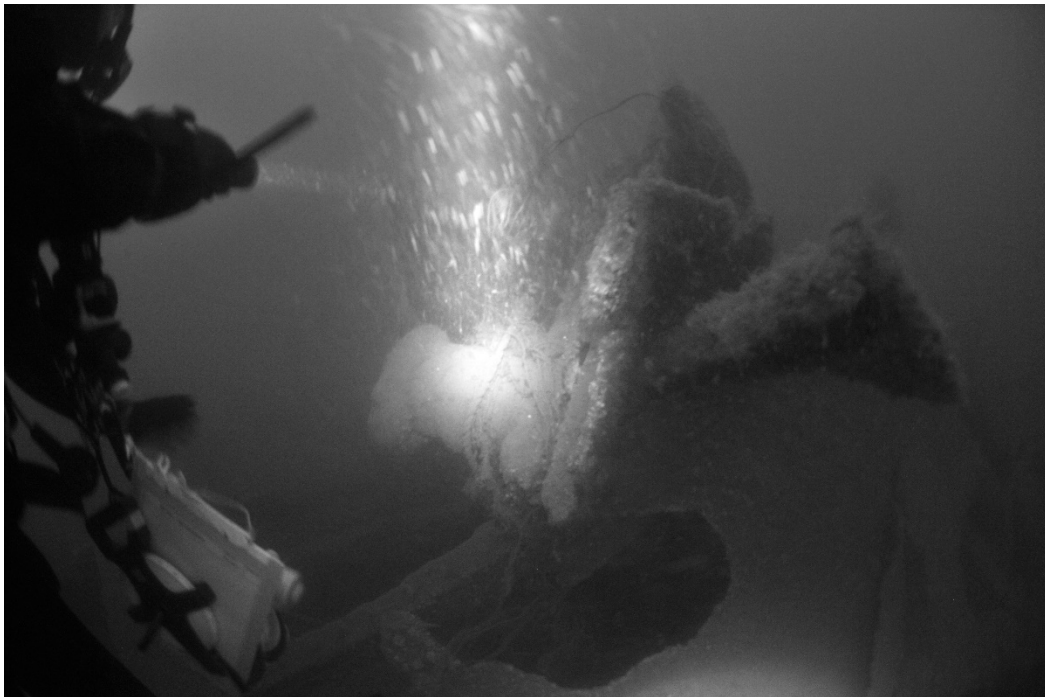
Two bollards are apparent on both the port and starboard side of the forward end of the wreck (Figure 5) with a winch or windlass present near the bollards on the port side (Figure 6). Part of the winch is covered with rope still coiled around a drum.

Figure 5: Bollard forward end of the wreck (image Roland Brookes)

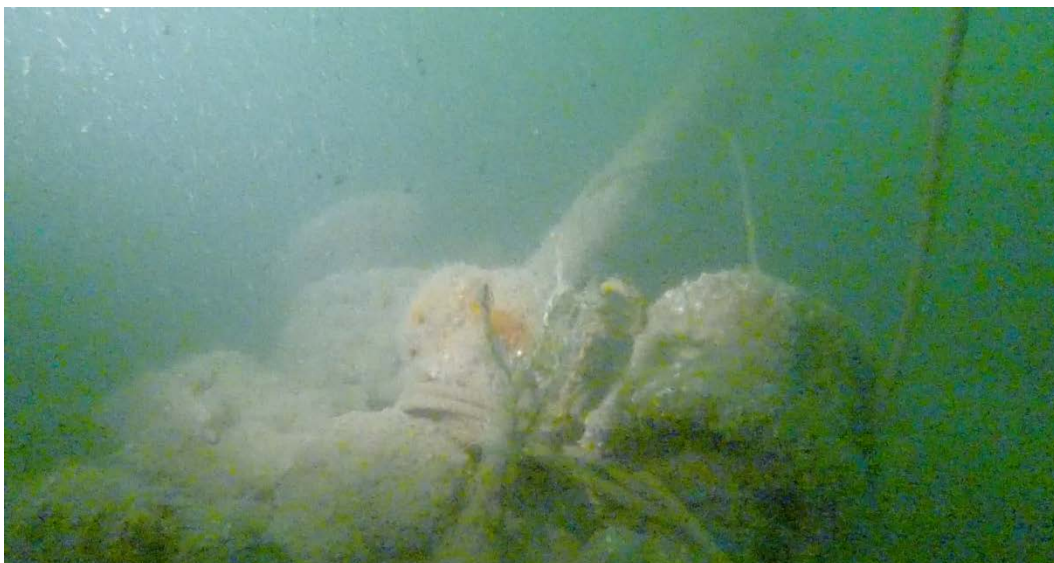
Figure 6: Winch, rope coiled around a drum to the left of the image

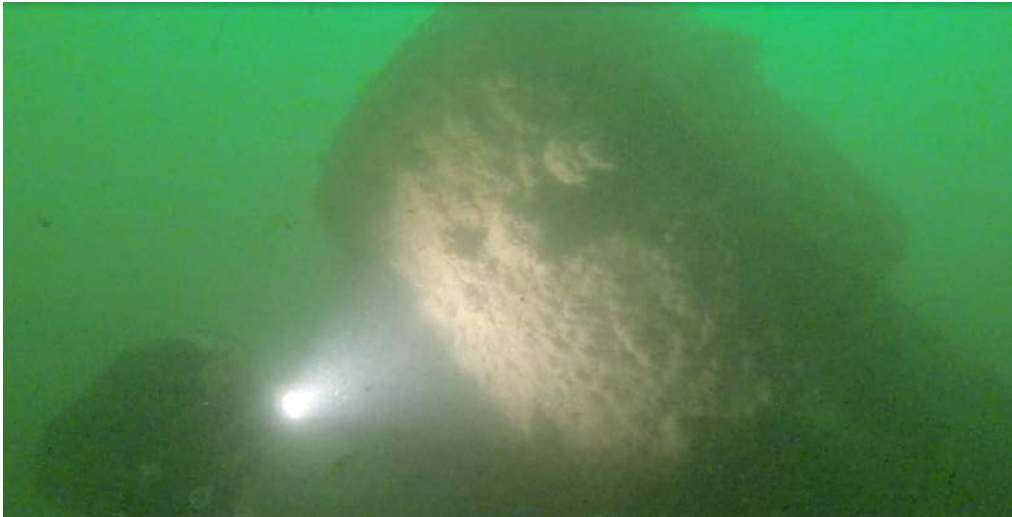
The highest point of the wreck is around amidships section with one of the boilers in this area having rolled out of its original position. The large triple expansion engine just behind has a large section of the hull resting against it as it tilts over still on its substantial legs (Figure 7 and 8).

Figure 7: Looking up at the engine machinery

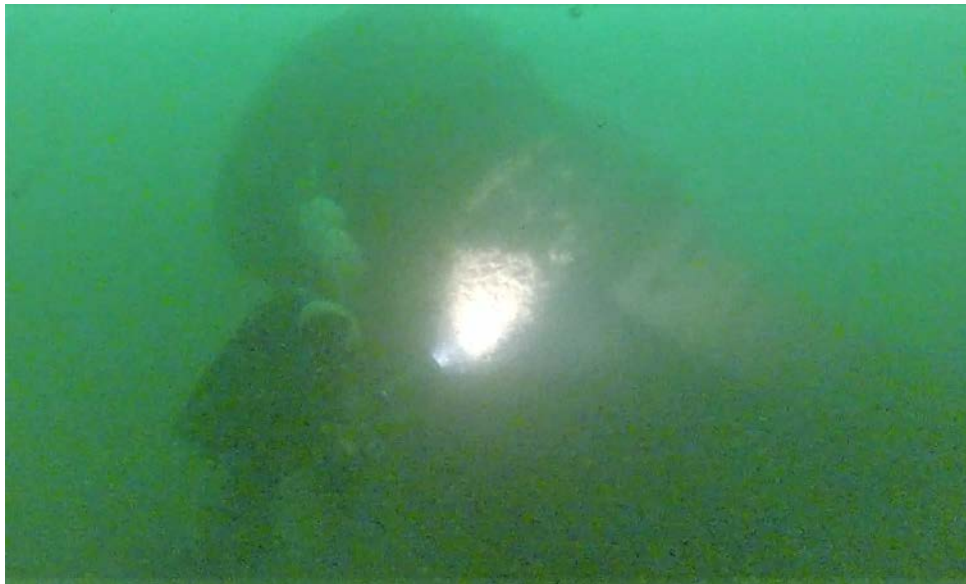
Figure 8: The legs of the engine can just be seen to the right side of the image

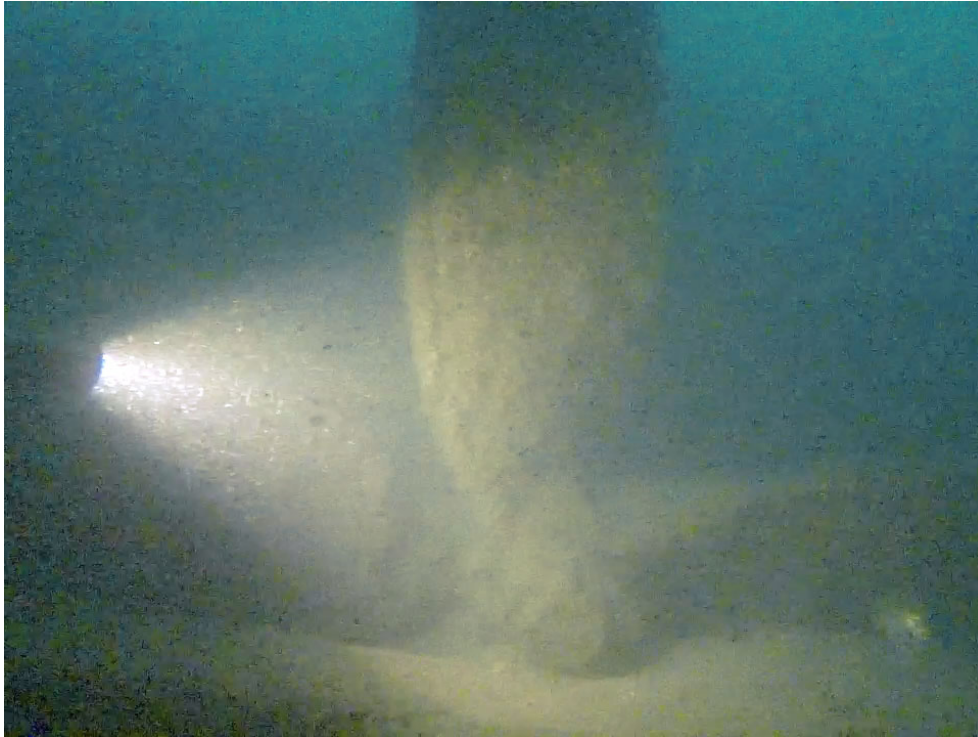
At the stern the four bladed propeller can be seen resting on the seabed (Figure 9 and 10) and the gun is still present at the stern although this was not encountered on this occasion. Coming forward from the stern along the starboard side access to the hold is possible in the aft part of the wreck, and a deck winch is present on the port quarter. Also on the port side, the bridge deck and its rails can be seen where it has slipped off the wreck onto the seabed. A video was taken around the wreck and the video tour can be seen on line at: <https://www.youtube.com/watch?v=Bcwxm6oqCck>

Figure 9: The four bladed propeller resting on the seabed

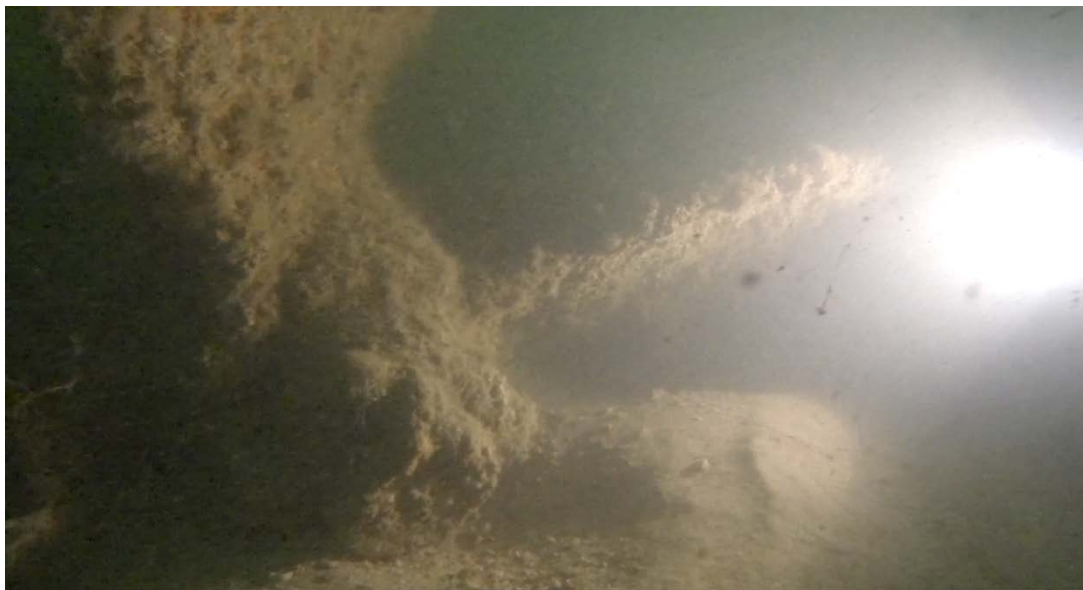
Figure 10: Propeller on seabed
